# *From the Garage*

*by Paul Hunter*

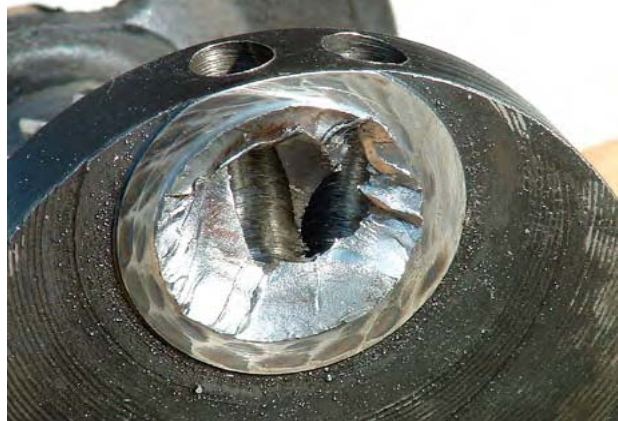
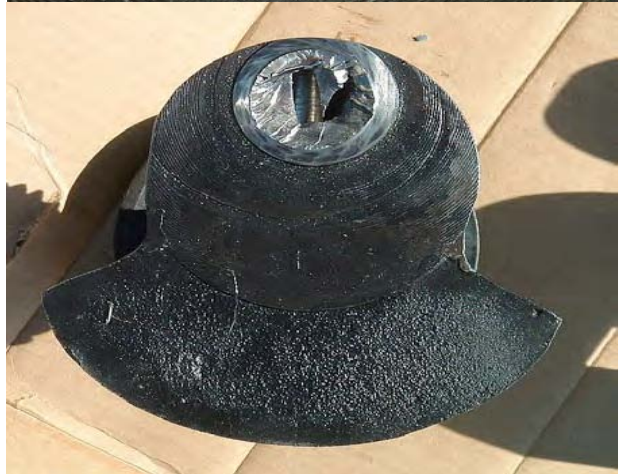
As some of you know, we were on our way to the highway clean up when our coupe's engine began to pound. I'm not talking a valve clack, I'm talking a full on, Quasimodo pounding of the bells. Luckily, we were right at the George Washington exit, so we coasted off the ramp, and limped her home. I was sure it was a rod pounding, and waited for it to come crashing through the pan or the side of the block. But, luckily it didn't. We both breathed a huge sigh of relief when I shut her off in the garage. A couple of days later I dropped the pan expecting to see a total mess in the bottom end. There was nothing obvious staring at me. The good news in all of this was I discovered I had a counterweighted crank. I checked the pan and found babbit in the pan baffle. When I looked more closely at the rod caps, I noticed chunks of babbit missing from the thrust bearing surface on the sides of the caps. I pulled number one cap and it had problems inside the cap itself. When I pushed up the rod, the whole babbit fell out in one piece. Not good. There were plenty of shims in the caps, so the babbit was redone at some point. Number two rod had the babbit coming loose in chunks and the cap was splintered. Number 3 rod had an extra hole in it and spider web cracks all around the hole.

I was convinced I had gotten a bad batch of babbit. When I talked to people more knowledgeable than myself, they felt it was more likely a wrist pin causing the noise because the pounding was on acceleration, instead of deceleration. Now I had to sweat a groove in one of the cylinder walls. I had a friend over when I pushed out the pistons, and there was no problem with the pins nor the cylinder walls. I figured I could get

away with a new set of rods and some rings, and put her back together. I spun the crank to make sure the mains felt okay, which they did. But, there was a strange clunking when the crank was turned. I asked my friend if he heard the clunk, and he had. Picking up the drop light, he had me move the crank back and forth while he checked the piston bores. Almost immediately he told me he saw the problem. I crawled out from under the car, took the light and checked number one bore. A blind man could have seen the problem. There was a crack in the crankshaft about an eighth of an inch wide, just behind the counterweight for number one rod. I pulled the engine from the car, and took it down to almost the bare block. When I finally got the main caps off, I was able to lift the crank out of the engine. Unfortunately, it was in two pieces. I don't know how we managed to drive it home. If it had splintered parallel to the crank center, I would have figured it held itself together with the edges of the break. But it was a clean break, as the picture shows. When I took the crank outside in the sun, the reason for the break became readily apparent. I'm not a machinist, but someone drilled the holes to balance the crank way too deep; through the center of the number one rod journal actually. Once again, the fickle finger of fate has struck. I bought the car with the engine "rebuilt." I'm sure it was, but who ever assembled it didn't care too much about the quality of their work. I'll be charitable and give them the benefit of the doubt - stuff happens. Even when you think you finally have everything covered, you don't. It's all part of the joys associated with owning old cars.
