From the Garage -

Number Eight! by Tom Endy

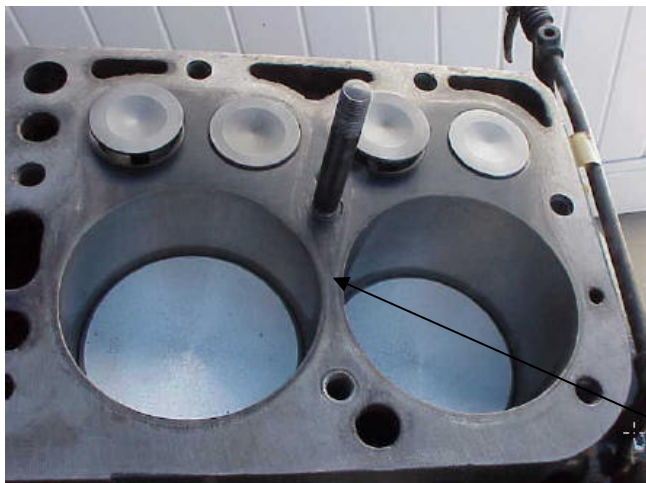
The #8 stud sits right next to the narrow area between #3 and #4 cylinder

The best solution is to remove the clamp completely from the armoured cable and install a spacer under the nut at the #8 stud to properly space it. Torque all the head bolts down to the proper specification in sequence, and don't fool with them when out on the road.

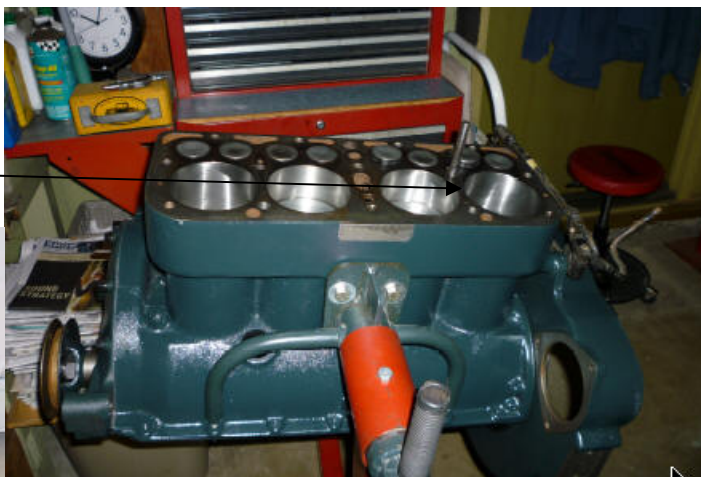
The area between #3 and #4 cylinder is a common place for a blown head gasket.

The #8 stud sits right next to the area.
