Technical Tip “Engine Knock” By Lynn Sondena

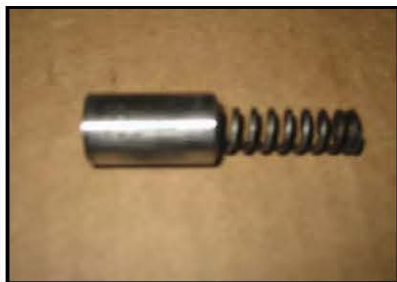
Fig 1

First, the camshaft thrust plunger (A-6275) and spring (A-6276) should be replaced with new American made units (Fig.1). These need to be well lubricated when assembled. Old units can have wear and weak springs. The original units are hard to test, due to the lack of specifications. A weak spring or worn plunger allows the camshaft to move back and forth making an engine knocking noise. This noise can be mistaken for rod or main bearing knock (Fig.2). A side note is that the movement of the camshaft will cause wear on the oil pump/distributor drive gear (A-6551).

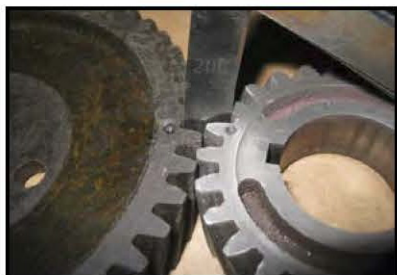
Fig 3

Second, check the backlash between the timing gear and the crankshaft gear. This is measured with a feeler gauge and should read between .003” and .005” (Fig.3). If you are getting excessive backlash you can use an oversized gear, either .003” or .005”.

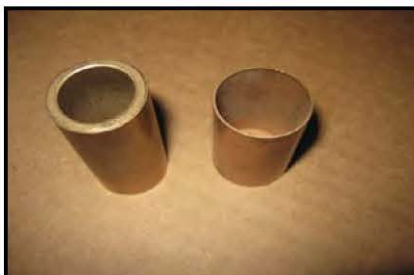
Fig 4

Fourth, the camshaft center journal with the drive gear should have a diameter of 1.557” or larger, with no pits and good teeth along with no wear. Excessive wear on teeth or incorrect tolerances will cause a knock between the camshaft and oil pump/distributor drive gear, or the camshaft and block. The fix can be so-so (cheap) or very expensive. The cheap fix is to purchase an oversized oil pump/distributor drive gear in either .004” or .010”. The teeth are wider to compensate for the camshaft wear. The expensive fix is to purchase a new camshaft and maybe have the block machined for camshaft journal sleeves (bushings). (Fig.4).
