Technical Tip “Engine Knock” By Lynn Sondena

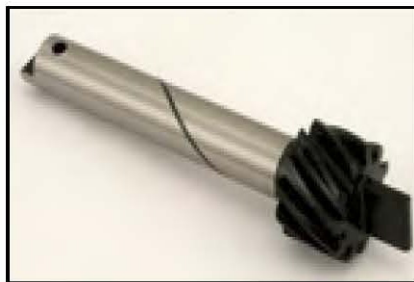
Fig 1

First, the camshaft thrust plunger (A-6275) and spring (A-6276) should be replaced with new American made units (Fig.1). These need to be well lubricated when assembled. Old units can have wear and weak springs. The original units are hard to test, due to the lack of specifications. A weak spring or worn plunger allows the camshaft to move back and forth making an engine knocking noise. This noise can be mistaken for rod or main bearing knock (Fig.2). A side note is that the movement of the camshaft will cause wear on the oil pump/distributor drive gear (A-6551).

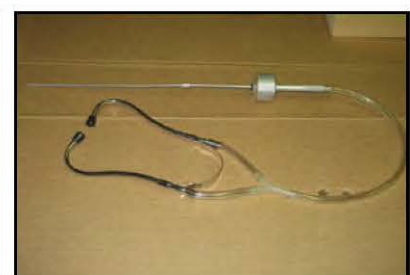
Fig 5

Remember that the Model A engine block is made from cast-iron with many hollow internal passages. This provides a very good source to resonate sounds. If you use an automotive stethoscope (much like a medical doctors stethoscope) to probe for the knocking noise, you can usually pin point the general area of the source of the noise (Fig.5). A safety note, is to keep the stethoscope probe away from the spark plug connectors, coil, fan blade & belt, plus the moving pulleys.
