## Flywheel Housing Alignment Pt 3

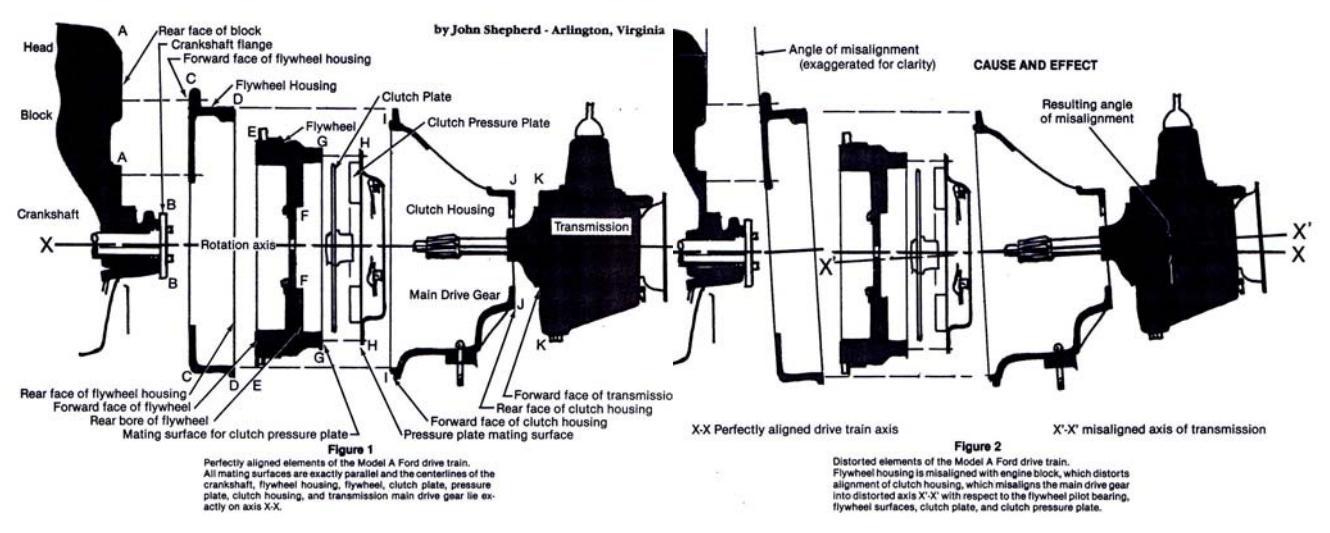
Figure 1 shows schematically a perfect aligned forward drive train. Note how the rear face of the engine block (A-A), the crankshaft flange (B-B), the forward face of the flywheel housing (C-), the rear face of the flywheel housing (E-E), the era bore of the flywheel (F-F), the mating surface for the clutch pressure plate (G-G), the pressure plate mating surface (H-H), the rear face of the clutch housing (J-J) and , finally, the forward face of the transmission (K-K) are all absolutely parallel, with their centerlines exactly on axis X-X.

Conversely, Figure 2, shows a misaligned forward drive train, the trouble having started when the flywheel housing was not installed exactly square with the crankshaft axis. Note how the centerline of the transmission drive gear shaft is cocked along axis X'-X' instead of along crankshaft axis X-X. But why is this bad?

With misalignment, each time the crankshaft turns, regardless of whether the clutch pedal is in or out, the flywheel also turns and grinds like a lather against the end of the drive gear shaft riding in the pilot bearing. Although this is the least serious consequence, it will cause frictional heat, noise, and premature wear of both the pilot bearing and shaft.

The real danger comes from the spline misalignment between the clutch plate and shaft. In normal operation, with the clutch pedal out, the clutch plate is squeezed against, and essentially locked to, the flywheel by force exerted by the springs in the pressure plate. The torque transmitted from the splines of the shaft. If the car is in gear, it moves. With things perfectly aligned, as in Figure 1, the clutch plate contact is uniform on the flywheel, the splines of the plate and shaft engages quietly and easily, and the engine torque is transmitted along a perfectly straight axis of rotation from the crankshaft to universal joint. In short, everything works as it was designed to.

Even when the clutch pedal is in there is very little clearance between the rotating flywheel and the forward face of the clutch plate, so major misalignment can cause the flywheel to rub against part of the plate, causing considerable unwanted frictional heat and some unwanted rotation of the clutch plate and drive gear. This is known as "dragging" clutch, with which quiet shifting of gears is practically impossible.

The major evil consequence of misalignment affects the clutch plate the most. Each revolution of the cocked shaft imparts tremendous non-uniform forces to the hub of the plate. Vibration, eventual destruction of the plate, clutch chatter, grabbing and dragging are almost inevitable. In non technical terms, the car drives just plain lousy.
